## RTK Setup – Software update for usage of PRN32 in RTK

### 1. Introduction

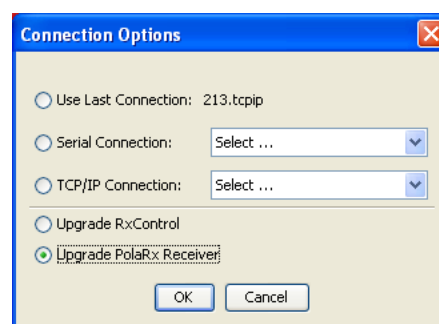
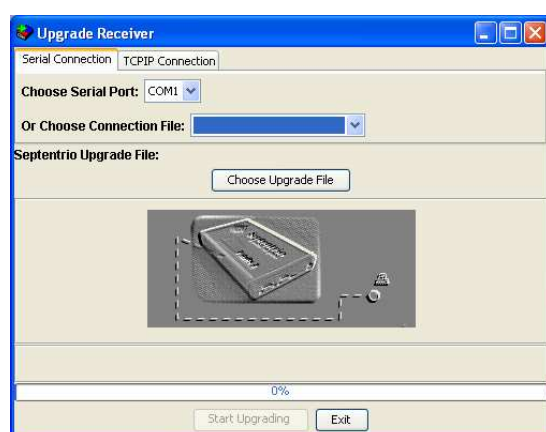
After clicking OK, the *Upgrade Receiver* dialogue appears. Depending on the connection you have with your receiver to the PC, you will need to choose the appropriate tab from this dialogue i.e. Serial Connection or TCP/IP Connection.

In the example, the Serial Connection is chosen. *Note that you always need to use COM1 on the receiver when you are upgrading via serial port.*

From this dialogue you can now choose the recommended upgrade files for upload on your receiver by clicking on the *Choose Upgrade File* button and selecting the corresponding file. This opens up the file browser allowing you to navigate through and to select the Septentrio Upgrade File (extension **.suf**).

After specifying the connection and selecting the upgrade file, the upgrade file can now be uploaded to the PolaRx2/2e firmware by clicking the *Start Upgrading* button. A progress bar and an animated screen monitor the upgrade process. The termination of the upgrade is signaled by a pop-up window warning the user that the PolaRx2/2e receiver has been rebooted. In case of failure, indicated by an error message, the receiver will reboot with the old firmware version.

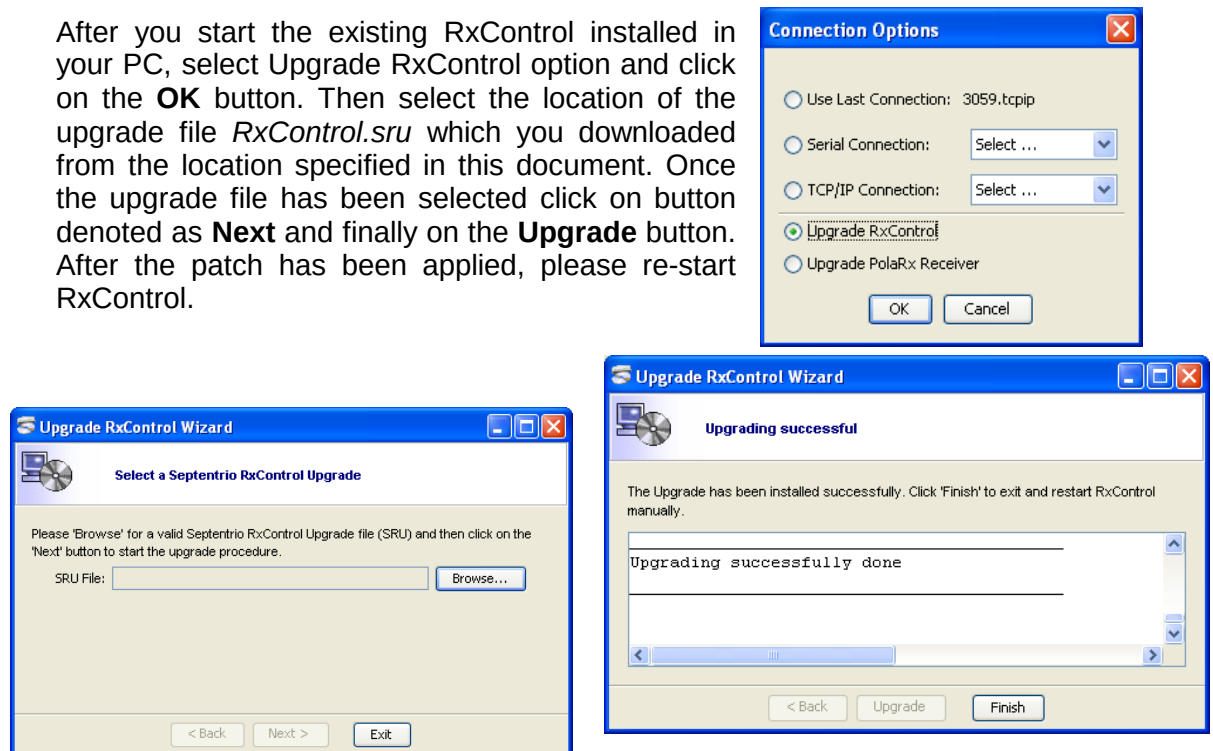
After you start the existing RxControl installed in your PC, select Upgrade RxControl option and click on the **OK** button. Then select the location of the upgrade file *RxControl.sru* which you downloaded from the location specified in this document. Once the upgrade file has been selected click on button denoted as **Next** and finally on the **Upgrade** button. After the patch has been applied, please re-start RxControl.
